WHEATLANDS METROPOLITAN DISTRICT REGULAR MEETING Wheatlands Clubhouse, 6601 S. Wheatlands Parkway, Aurora, Colorado May 11, 2023 at 6:00 p.m. <u>www.wheatlandsmetro.org</u>

NOTICE OF REGULAR MEETING AND AGENDA

MINUTES OF A REGULAR MEETING OF THE BOARD OF DIRECTORS

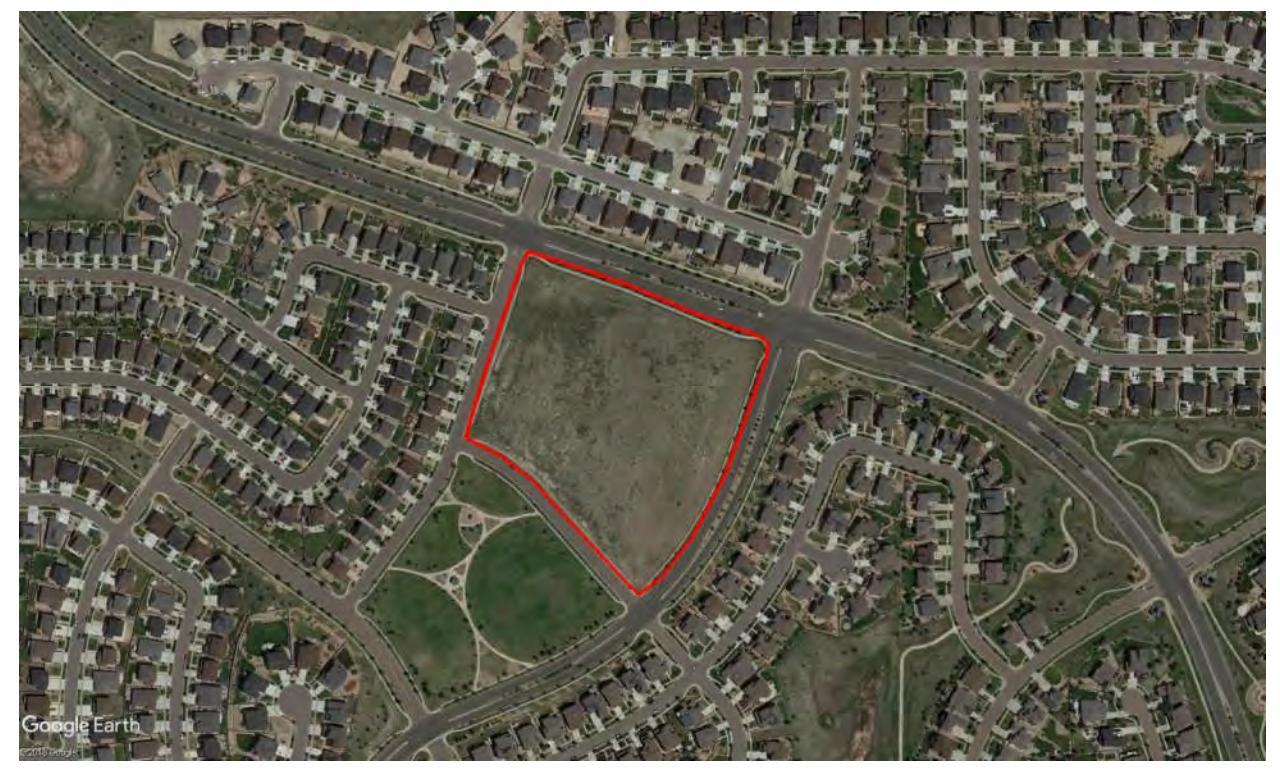
Photo 1 – Google Earth[©] Aerial Site Photo, 6/2017

As part of our investigation, we reviewed historical aerial photographs to evaluate previous site uses and their potential impacts. The earliest photos date back to 1937. The site appears to have previously been vacant or used as farmland up until March of 2006. Small check dams appear within a drainage on the site in a 1993 photo. In April of 2006 some grading of the site occurs in conjunction with the surrounding Wheatlands development. The small drainages on the site were obliterated or filled. Although not encountered in our borings, some fill may be present along the northern portion of the site where a drainage was filled to construct South Powhaton Road.

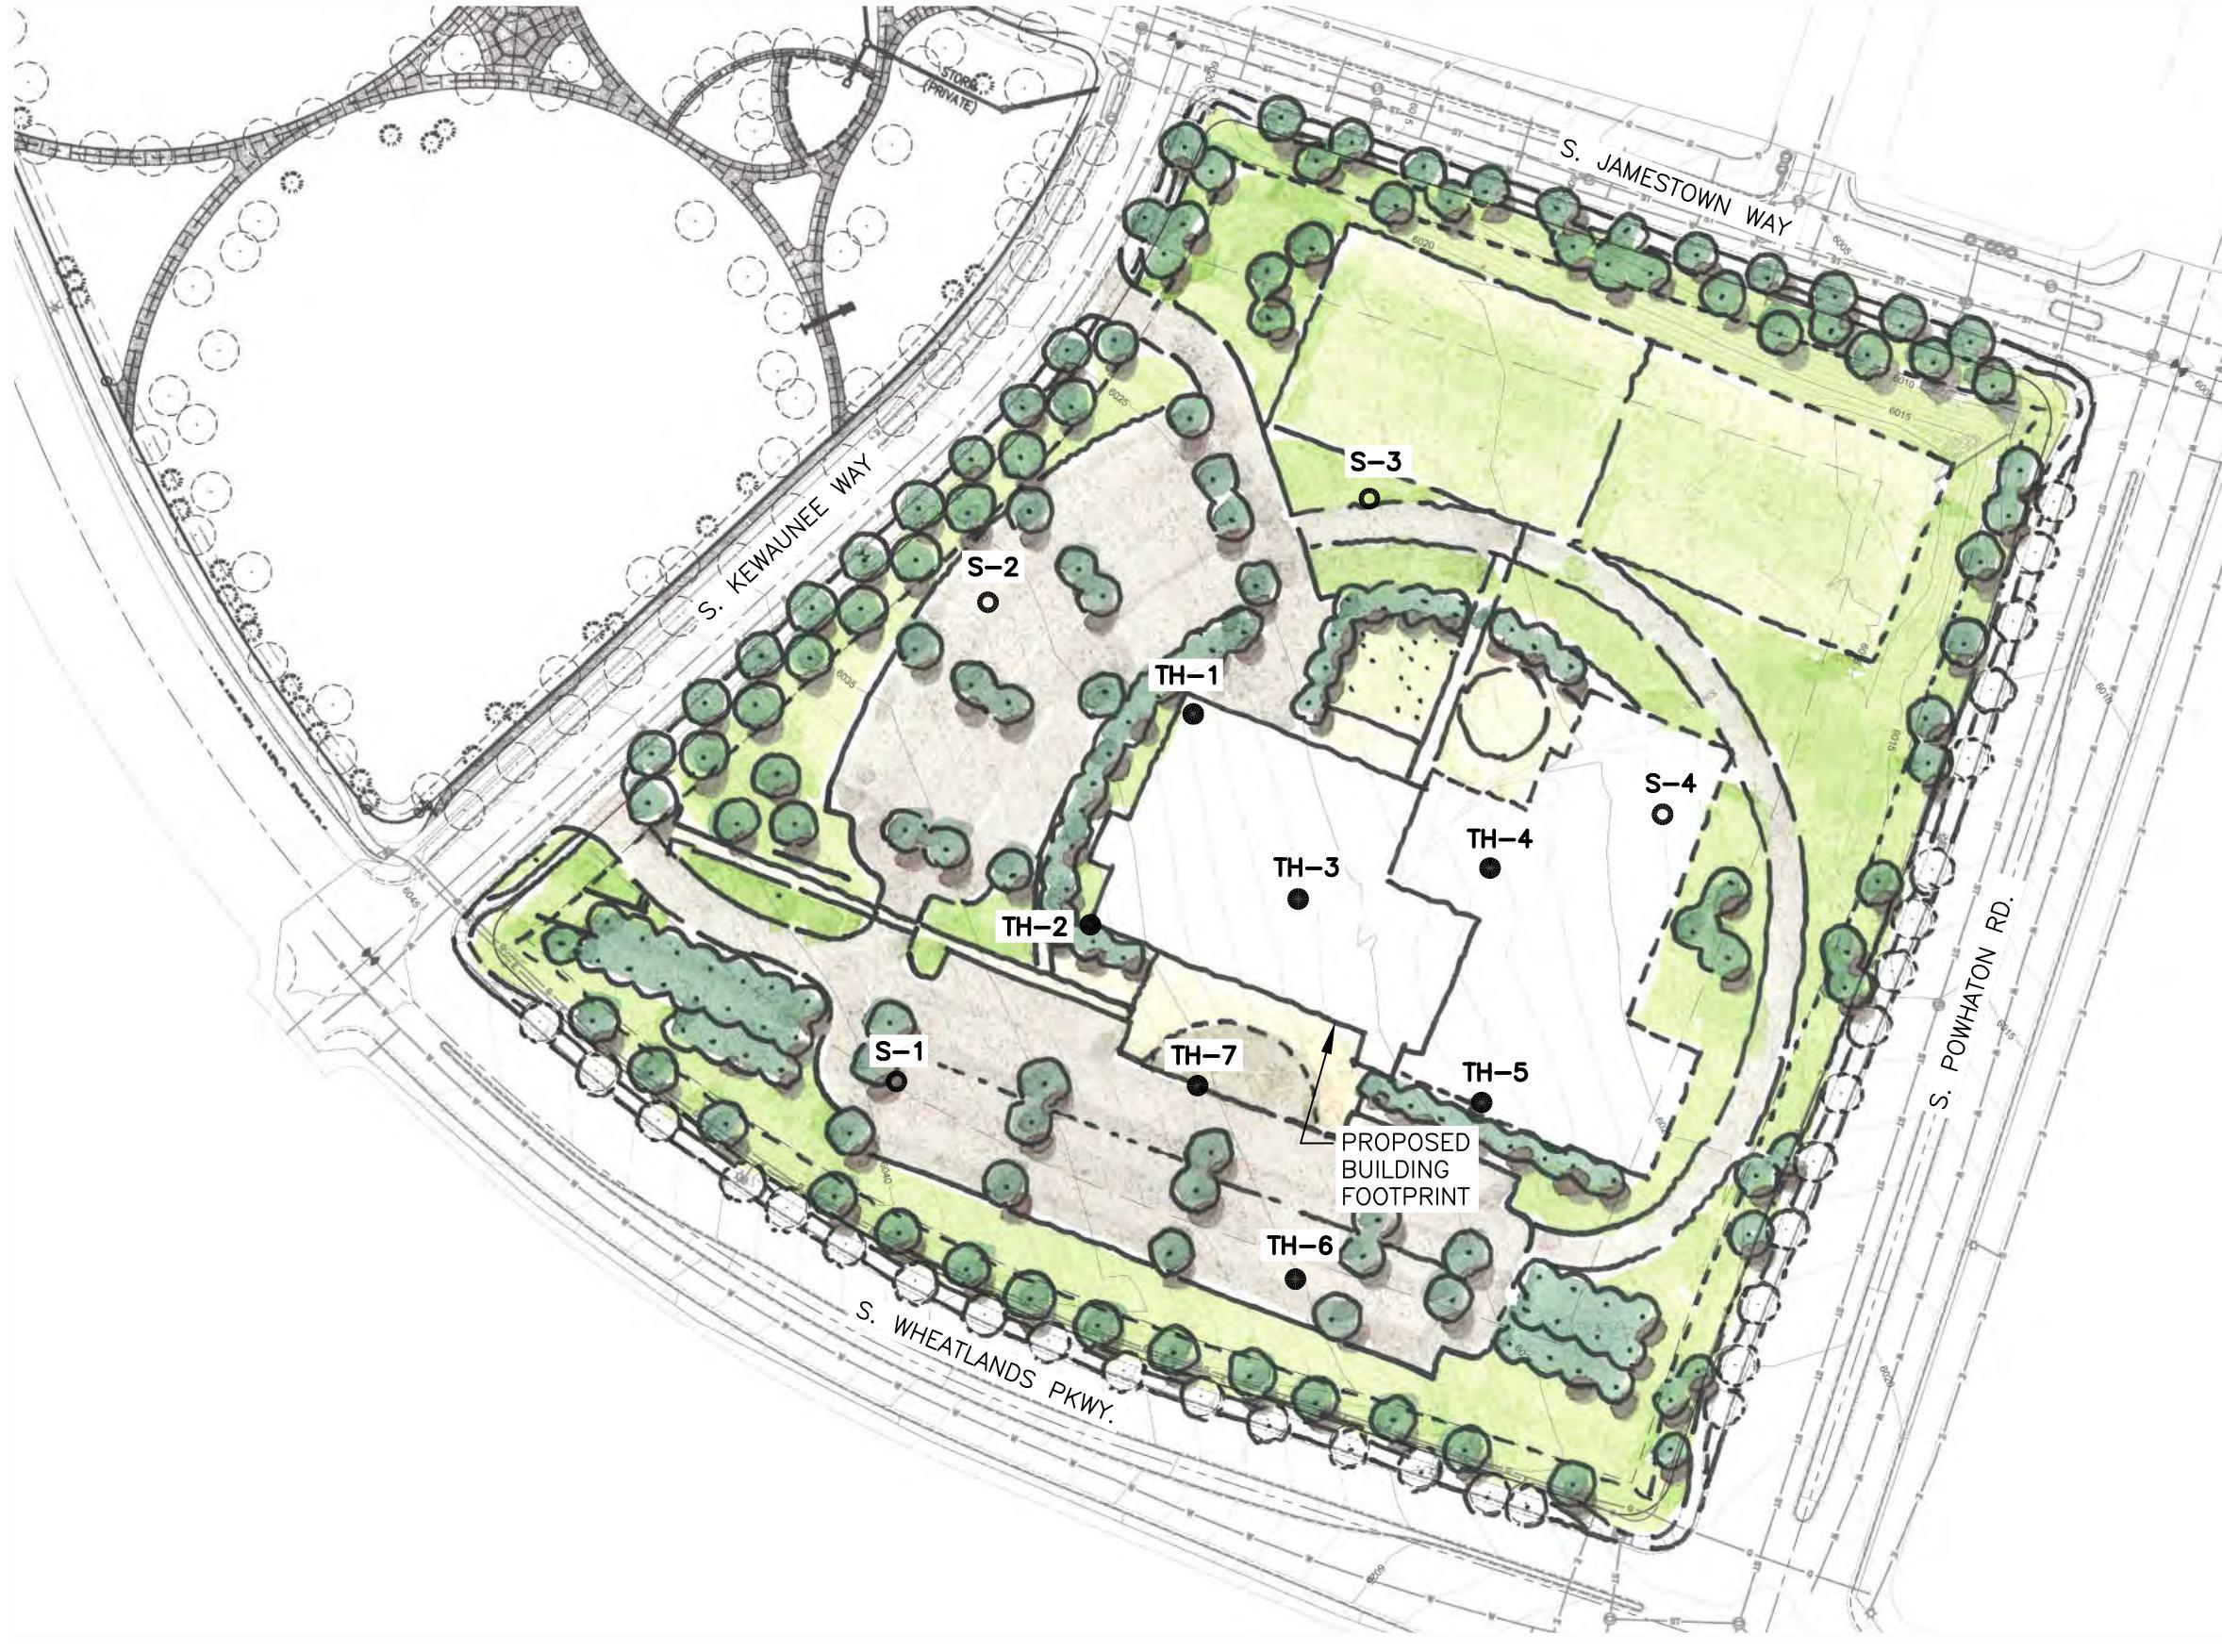
Locations of **Exploratory Borings** and Conceptual Development Plan Fig.⁷² 1

We investigated subsurface conditions on August 1, 2018 by drilling 11 exploratory borings at the approximate locations shown on Fig. 1. Seven deep borings were drilled within the planned building footprint and 4 shallow borings were in proposed access drives and parking areas. The conceptual site layout changed after drilling had been completed. We surveyed the boring locations using a Leica GS18 GPS unit. Prior to drilling, we contacted the Utility Notification Center of Colorado and local sewer and water districts to identify locations of buried utilities. The borings were drilled to depths of 10 or 30 feet below existing grades using 4-inch diameter, continuous-flight solid-stem auger and truck-mounted BK-51 drill rig.

This report presents the results of our Geotechnical Investigation for the new Wheatlands YMCA Recreation Center planned southwest of South Powhaton Road and South Wheatlands Parkway in Aurora, Colorado (Fig. 1). The purpose of our investigation was to evaluate the subsurface conditions and provide geotechnical design criteria for the building and pavements. The scope was described in a Service Agreement (DN 18-0292R2) dated July 23, 2018. Evaluation of the property for the possible presence of potentially hazardous materials (Environmental Site Assessment) was not included in our scope.

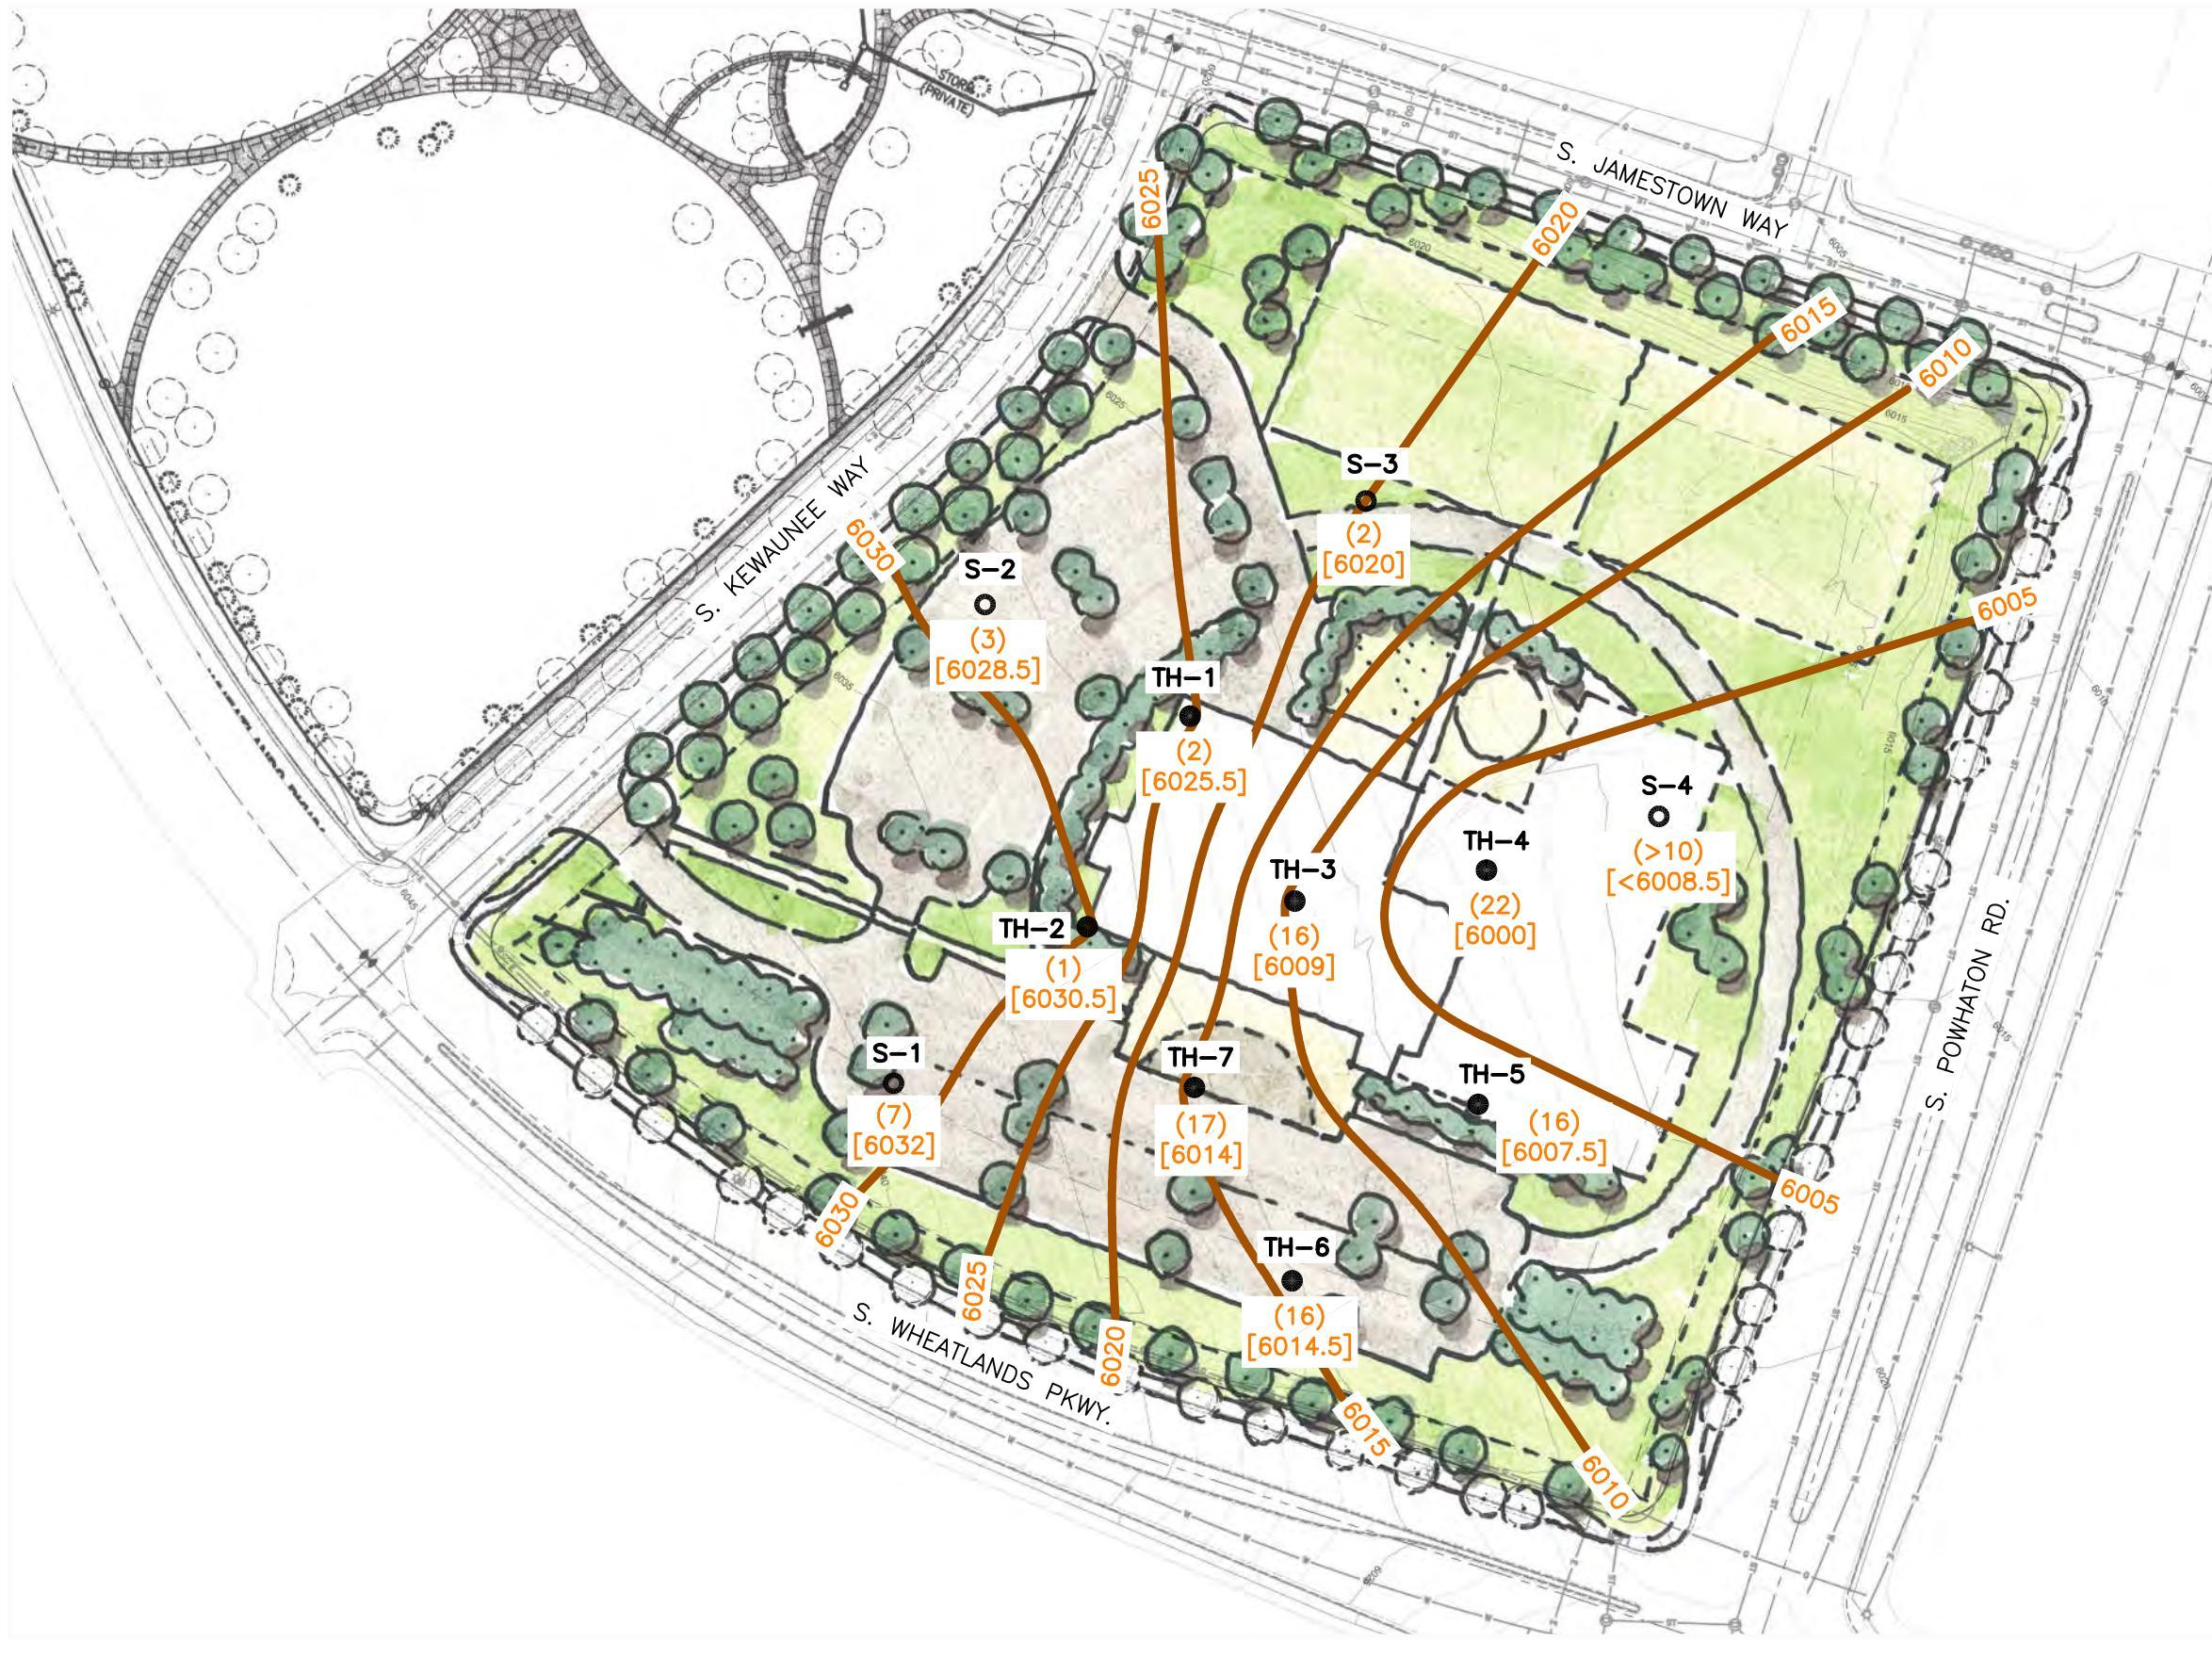
Estimated Elevation and Depth to Bedrock Fig.⁷³ 2

_EGEND:	
TH—1	APPROXIMATE LOCATION OF EXPLORATORY BORING
S-1 O	APPROXIMATE LOCATION OF SUBGRADE SAMPLE
(2)	INDICATES APPROXIMATE DEPTH TO COMPARATIVELY UN-WEATHERED BEDROCK (FEET)
[6025.5]	INDICATES APPROXIMATE ELEVATION OF COMPARATIVELY UN-WEATHERED BEDROCK (FEET)
6030 ——	INDICATES ESTIMATED UN-WEATHERED BEDROCK SURFACE ELEVATION CONTOUR (FEET)
NOTE:	THIS ESTIMATE WAS BASED UPON A SUBJECTIVE ANALYSIS OF DRILL HOLE DATA AND MAY NOT REFLECT LOCAL VARIATIONS.

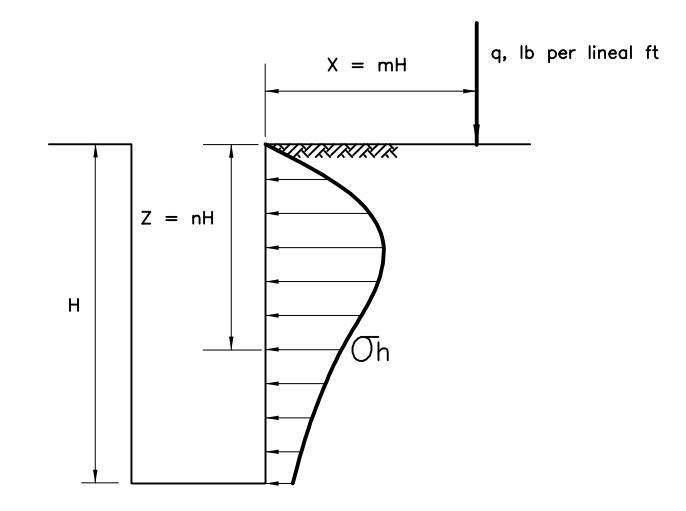
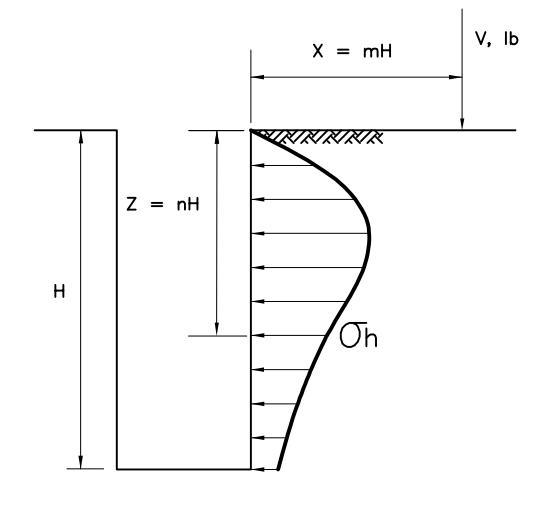
LATERAL PRESSURE AGAINST RIGID WALL DUE TO A LINE LOAD

q = LINE LOAD (plf)
q =
$$\frac{W}{L}$$

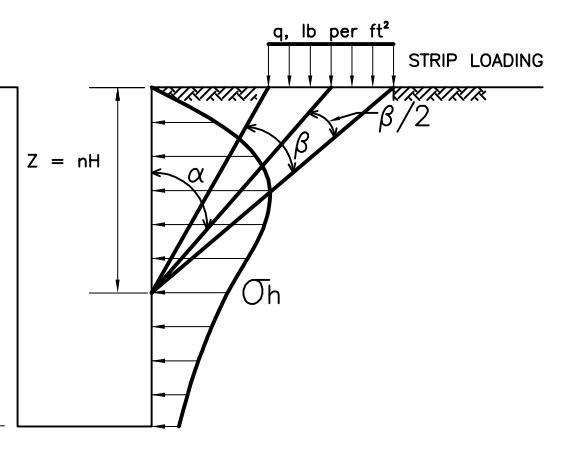
Surcharge Loads

LATERAL PRESSURE AGAINST RIGID WALL DUE TO A STRIP LOAD

```
O_h = LATERAL EARTH PRESSURE AT
       DEPTH Z DUE TO STRIP LOAD q
       \frac{2q}{\pi} (β-sinβcos2α)
```

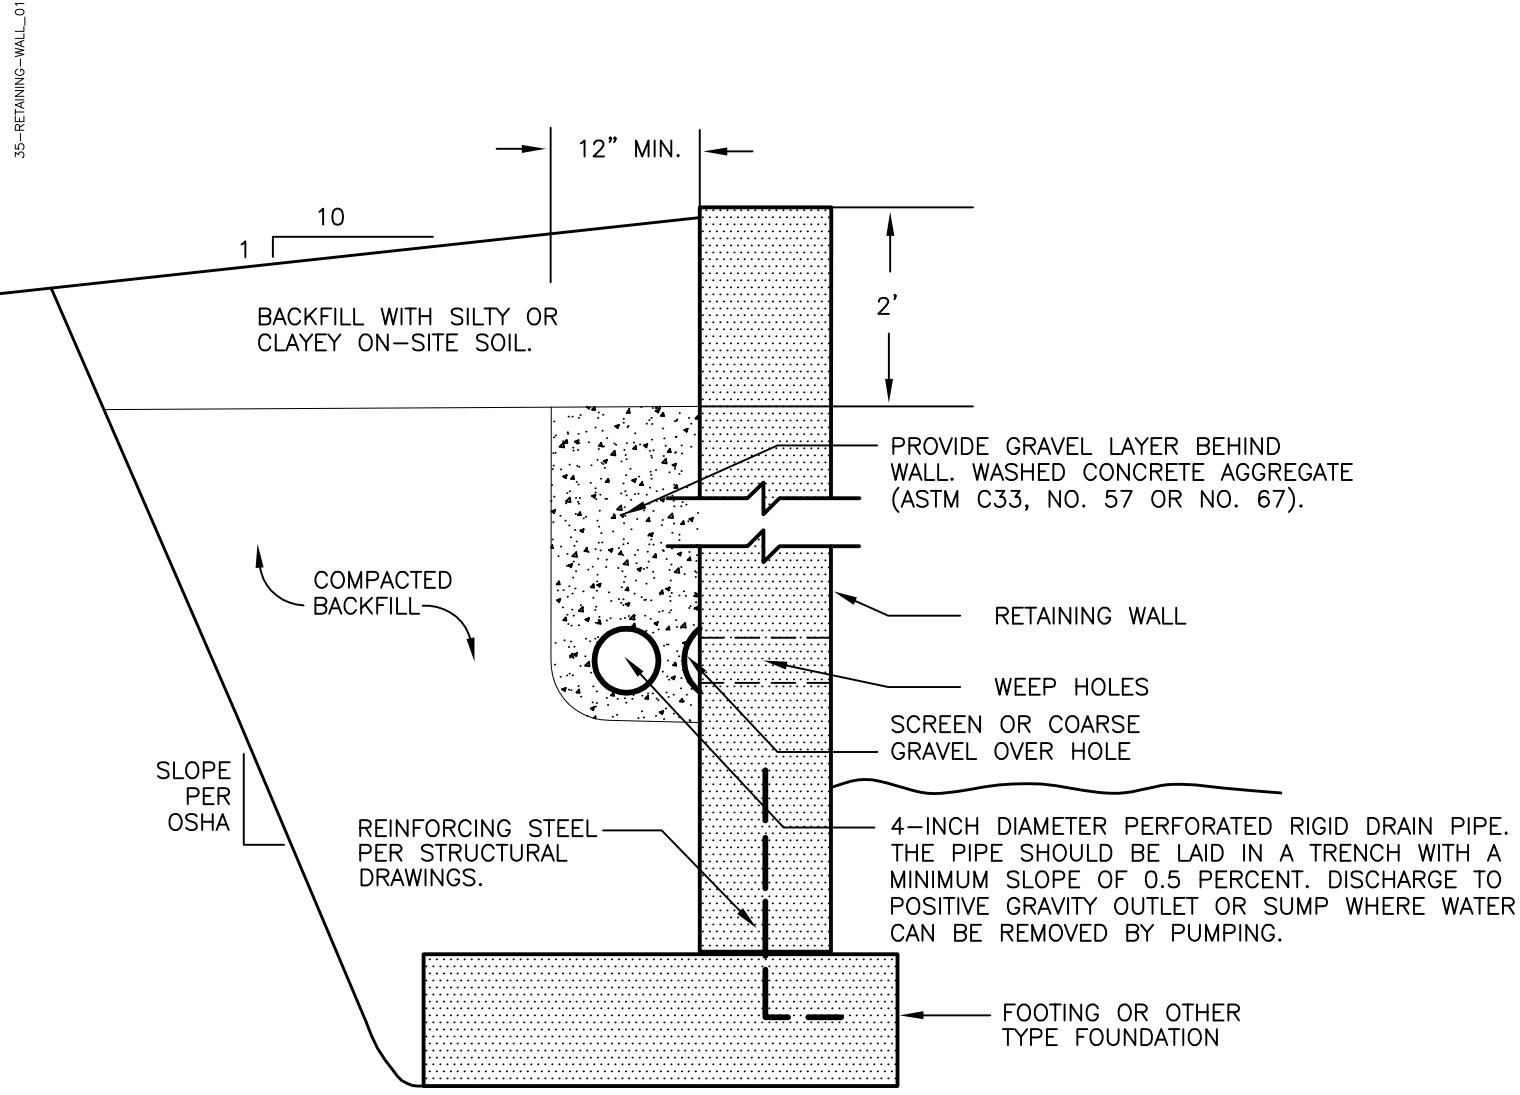
YMCA OF METRO DENVER WHEATLANDS YMCA CTL\T Project No. DN49,591-125-R1 **Typical Earth** Retaining Wall Drain

NOTE: DRAIN PIPE TO GRAVITY OUTLET OR WEEP HOLES MAY BE USED.

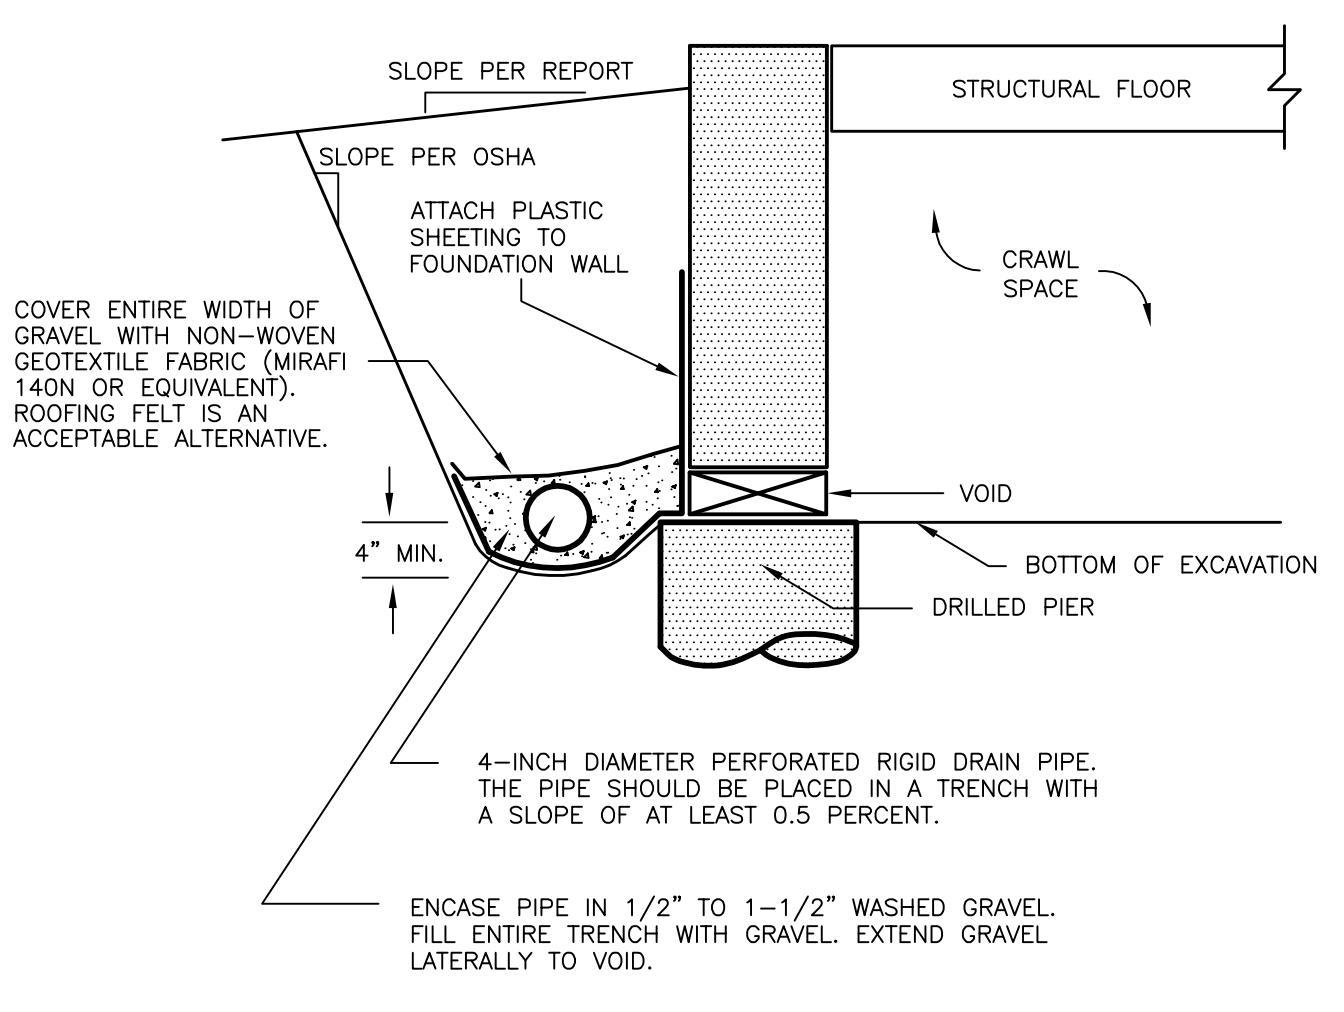
YMCA OF METRO DENVER WHEATLANDS YMCA CTL\T Project No. DN49,591-125-R1 Exterior **Foundation** Wall Drain Fig. 6

THE BOTTOM OF THE DRAIN SHOULD BE AT LEAST 4 INCHES BELOW BOTTOM OF VOID AT THE HIGHEST POINT AND SLOPE DOWNWARD TO A POSITIVE GRAVITY OUTLET OR TO A SUMP WHERE WATER CAN BE REMOVED BY PUMPING.

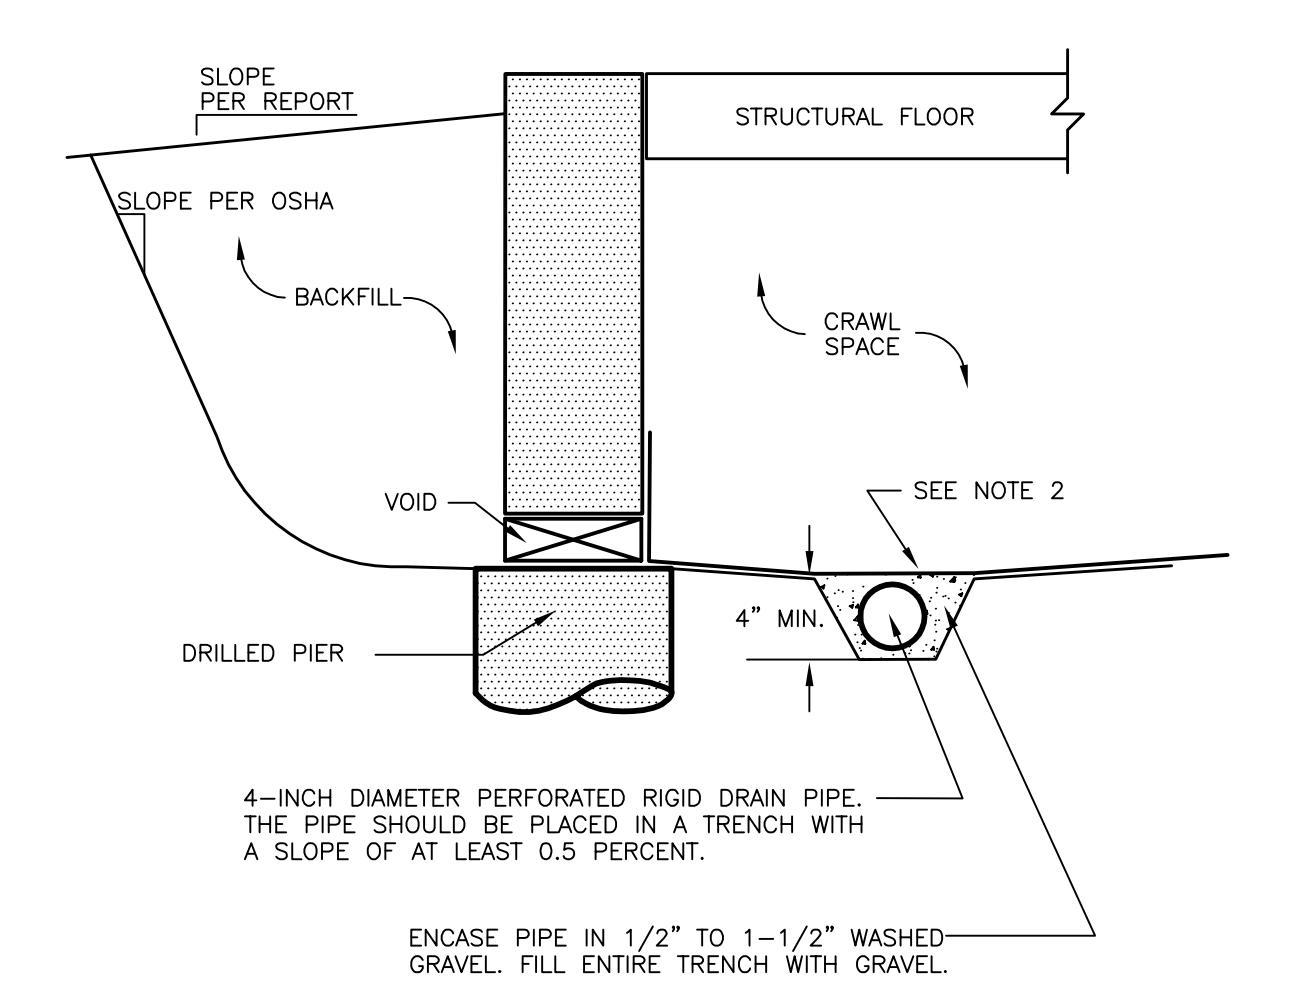
- 1) THE BOTTOM OF THE DRAIN SHOULD BE AT LEAST 4 INCHES BELOW BOTTOM OF VOID AT THE HIGHEST POINT AND SLOPE DOWNWARD TO A POSITIVE GRAVITY OUTLET OR TO A SUMP WHERE WATER CAN BE REMOVED BY PUMPING.
- 2) TO HELP CONTROL THE HUMIDITY IN THE CRAWL SPACE, A MINIMUM 6-MIL POLYETHYLENE VAPOR RETARDER SHOULD BE PLACED OVER THE CRAWL SPACE SOILS. THE RETARDER SHOULD BE ATTACHED TO CONCRETE FOUNDATION ELEMENTS AND EXTEND UP FOUNDATION WALLS AT LEAST 8 INCHES ABOVE TOP OF VOID. OVERLAP JOINTS 3 FEET AND SEAL.
