WHEATLANDS METROPOLITAN DISTRICT REGULAR MEETING Wheatlands Clubhouse, 6601 S. Wheatlands Parkway, Aurora, Colorado May 11, 2023 at 6:00 p.m. <u>www.wheatlandsmetro.org</u>

NOTICE OF REGULAR MEETING AND AGENDA

MINUTES OF A REGULAR MEETING OF THE BOARD OF DIRECTORS

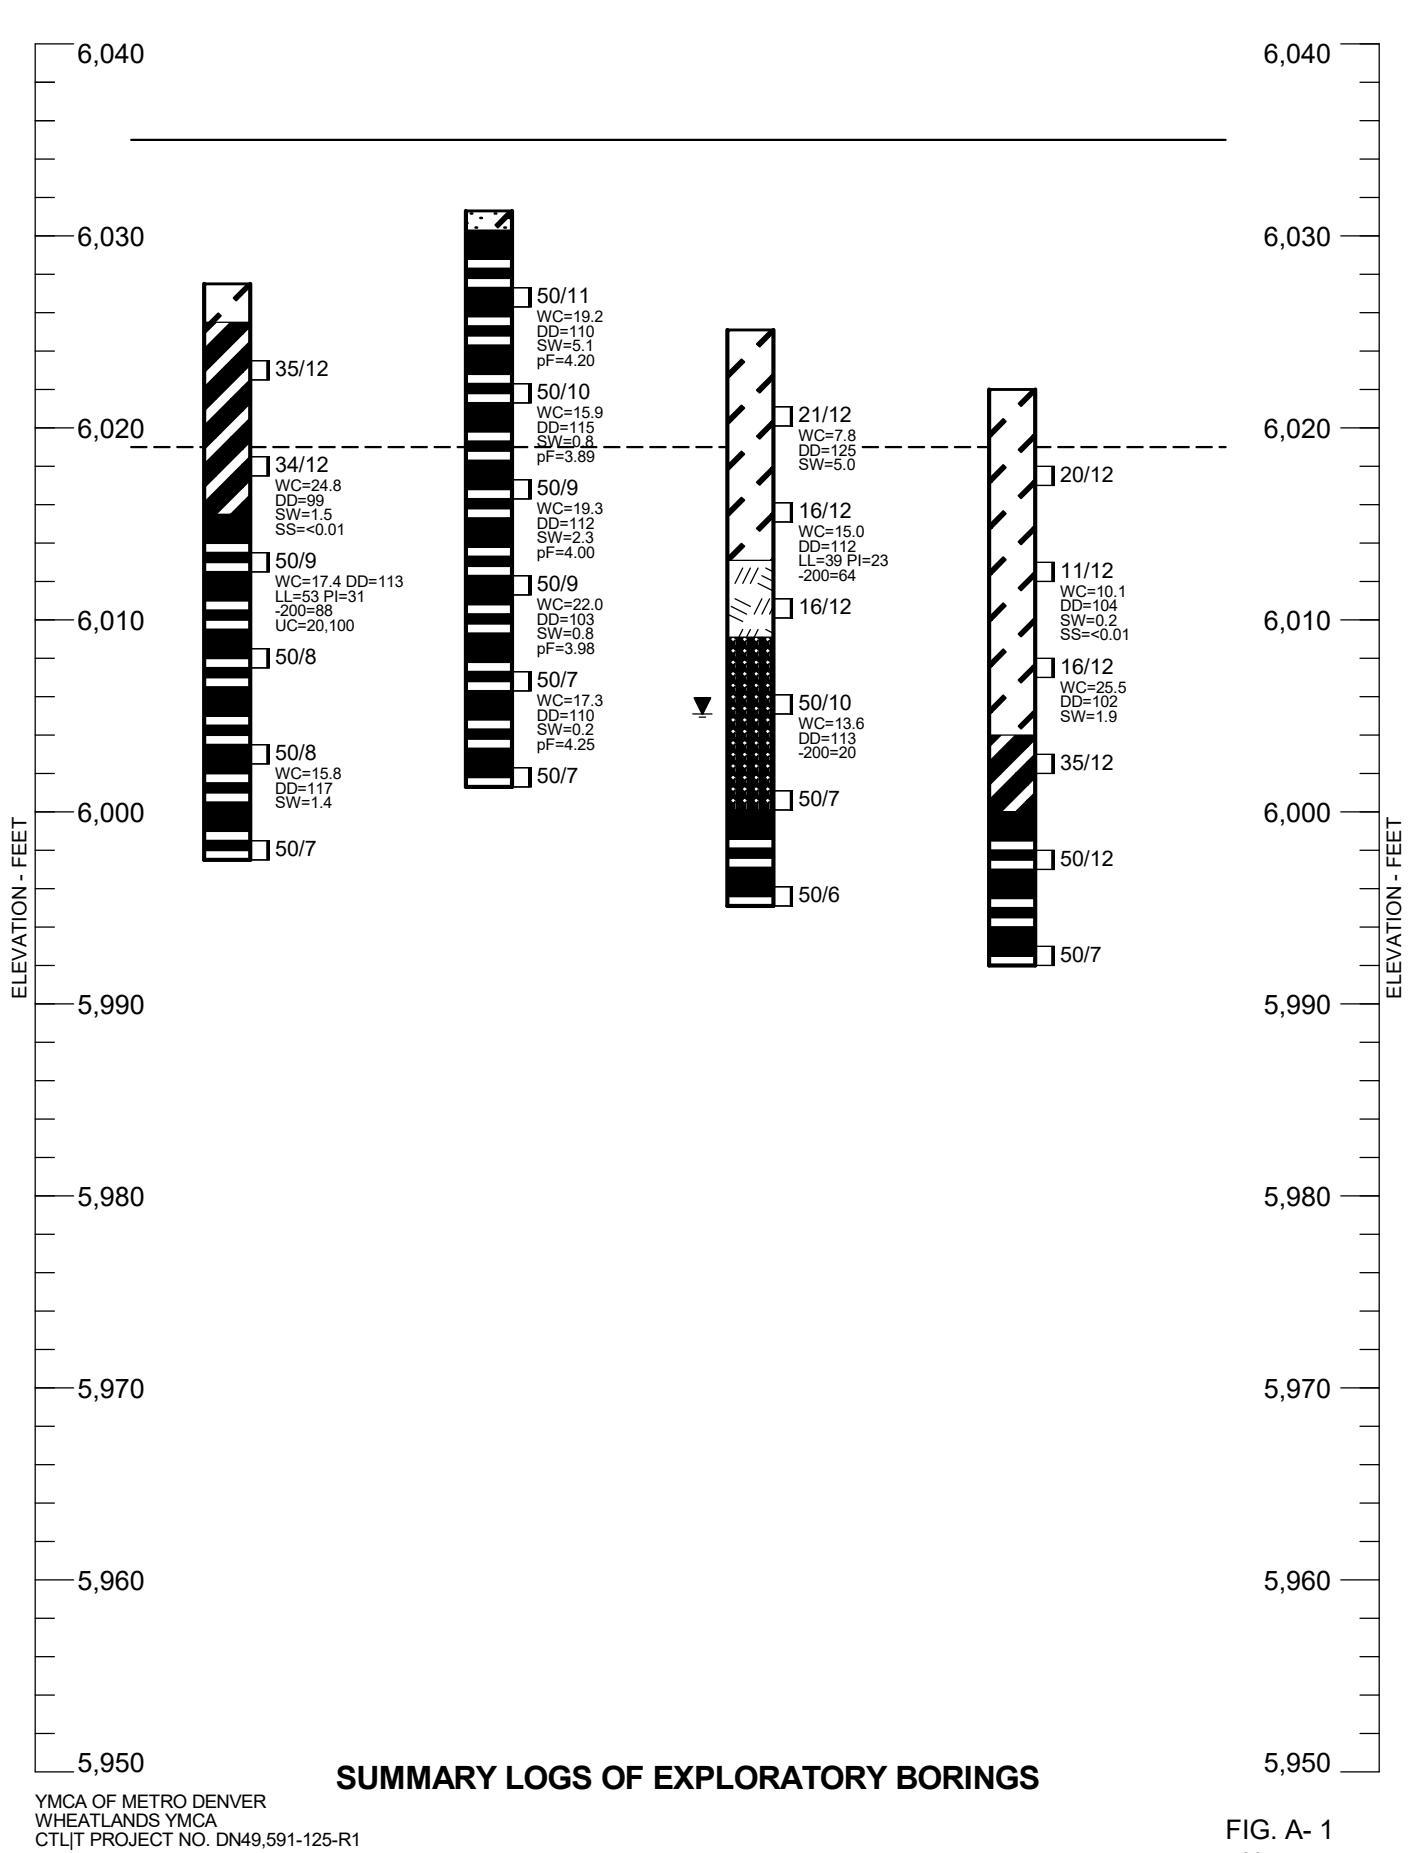
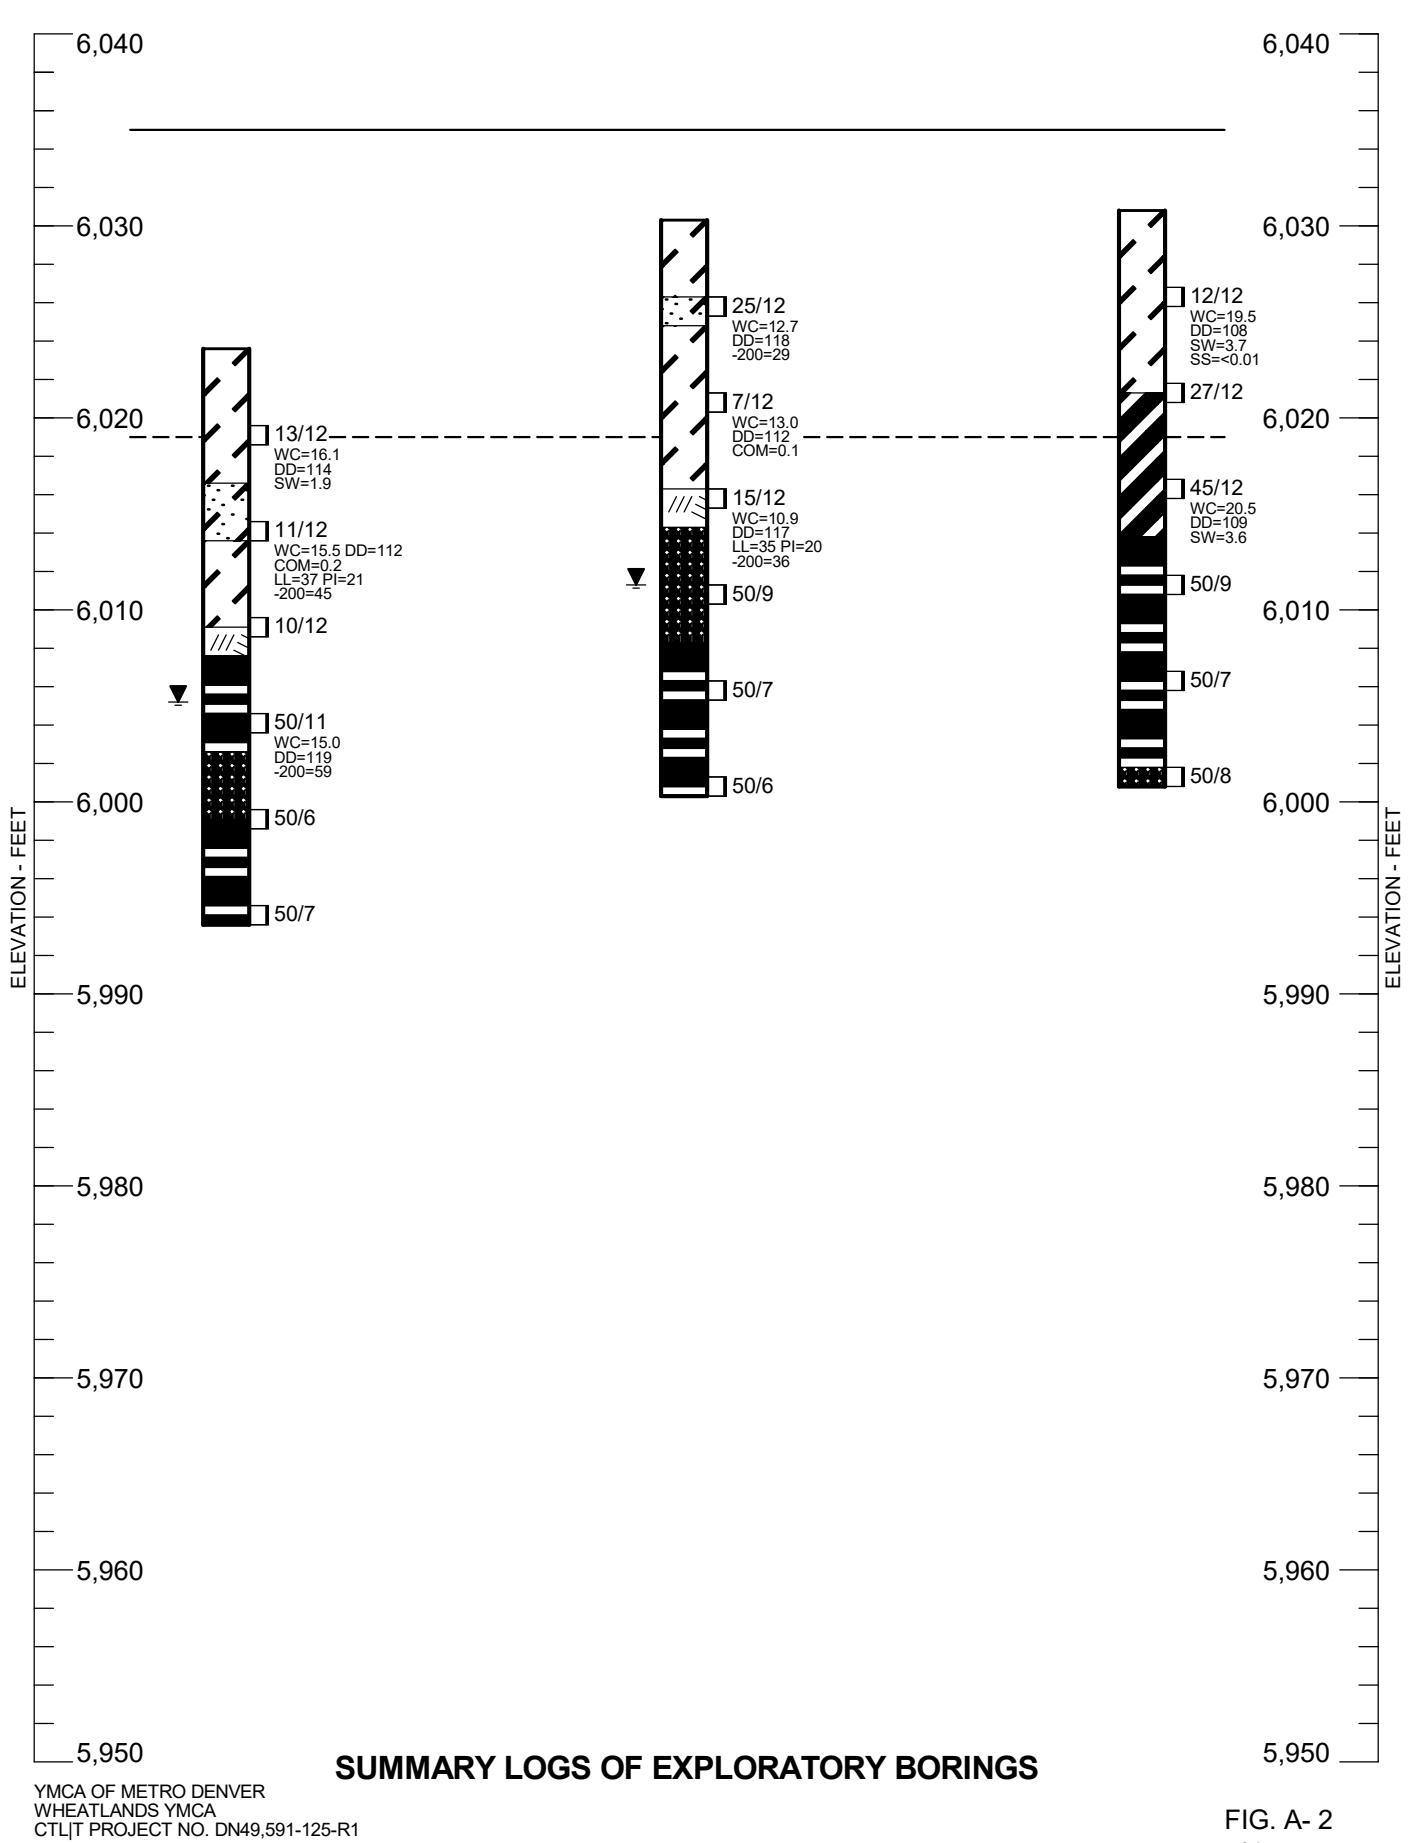
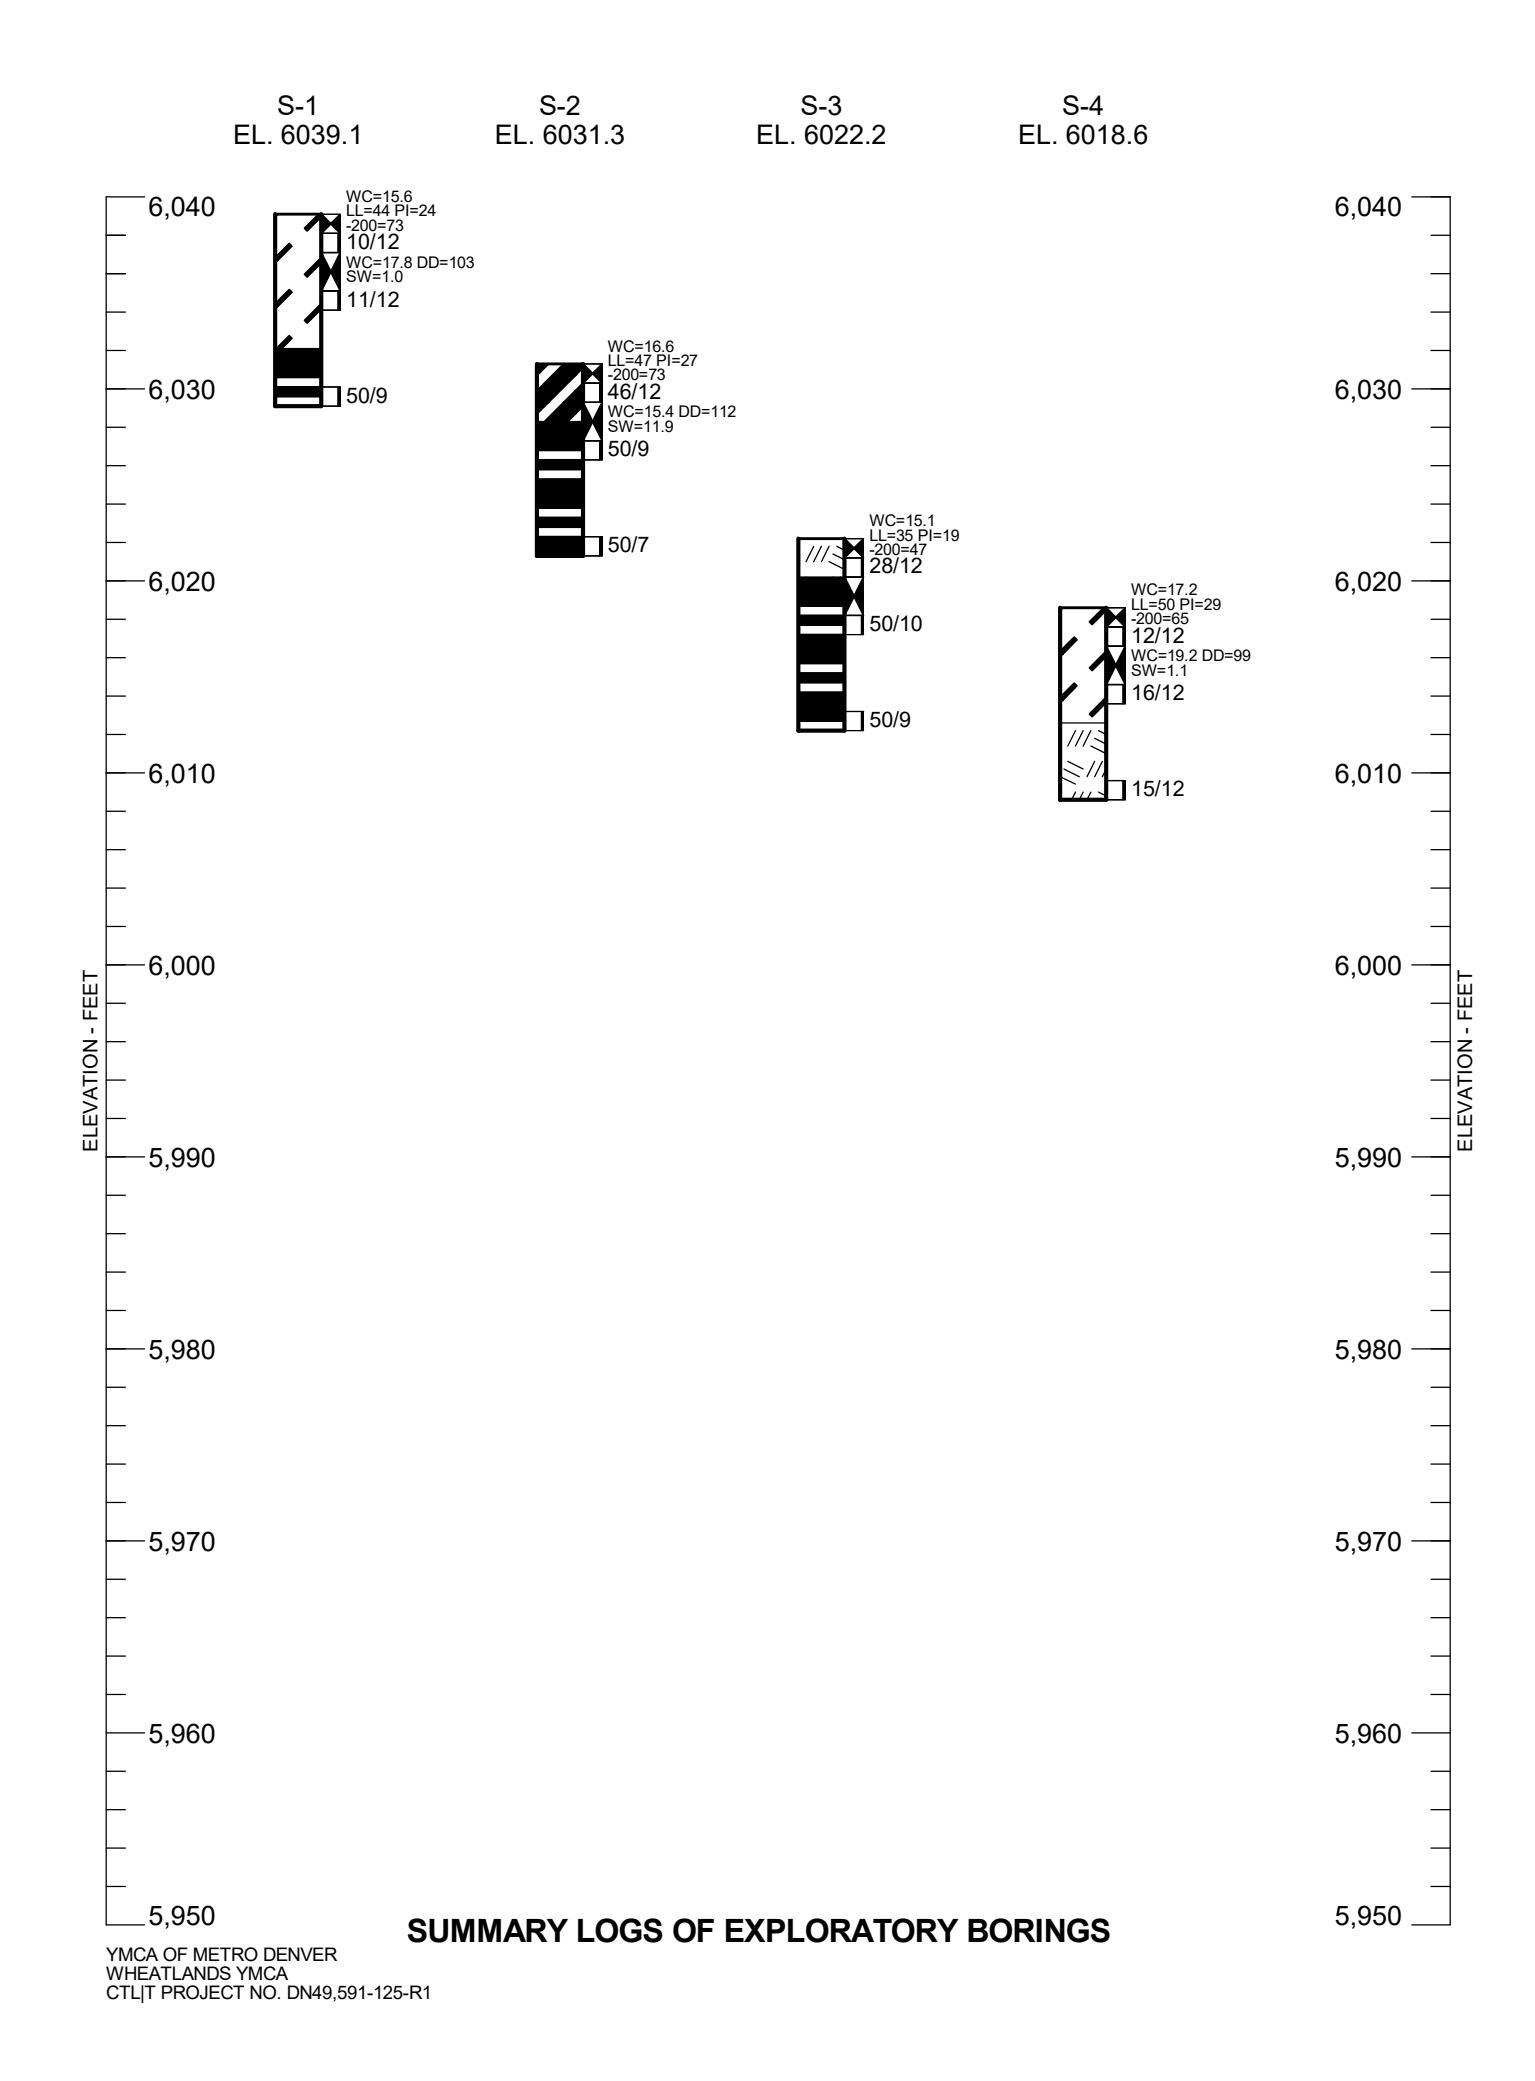
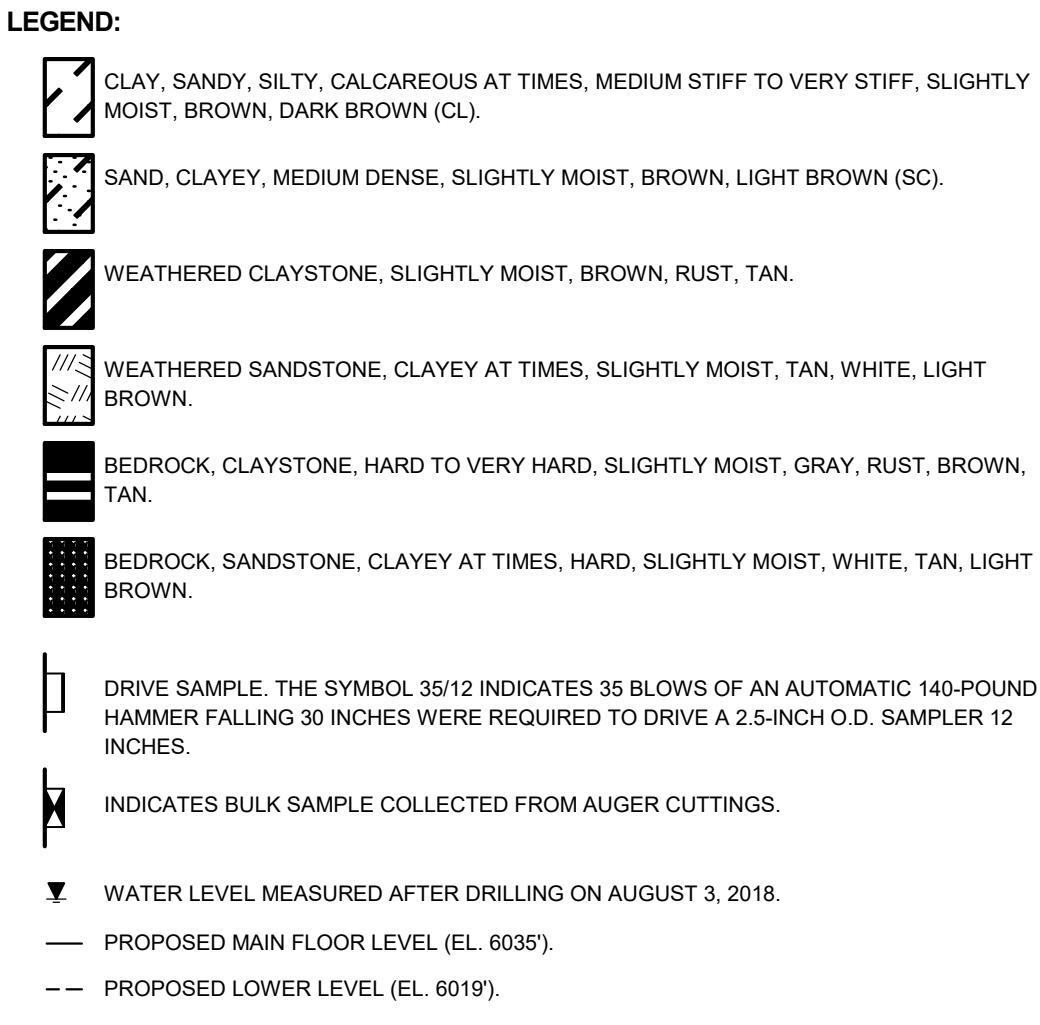
- 1. THE BORINGS WERE DRILLED ON AUGUST 1, 2018 USING 4-INCH DIAMETER, CONTINUOUS-FLIGHT SOLID-STEM AUGER AND A TRUCK-MOUNTED BK-51 DRILL RIG.
- 2. BORING LOCATIONS AND ELEVATIONS ARE APPROXIMATE AND WERE SURVEYED BY A REPRESENTATIVE OF OUR FIRM USING A LEICA GS18 GPS UNIT AND ARE REFERENCED TO THE NORTH AMERICAN VERTICAL DATUM OF 1988 (NAVD 88).
- 3. WC INDICATES MOISTURE CONTENT (%).
 - DD INDICATES DRY DENSITY (PCF).

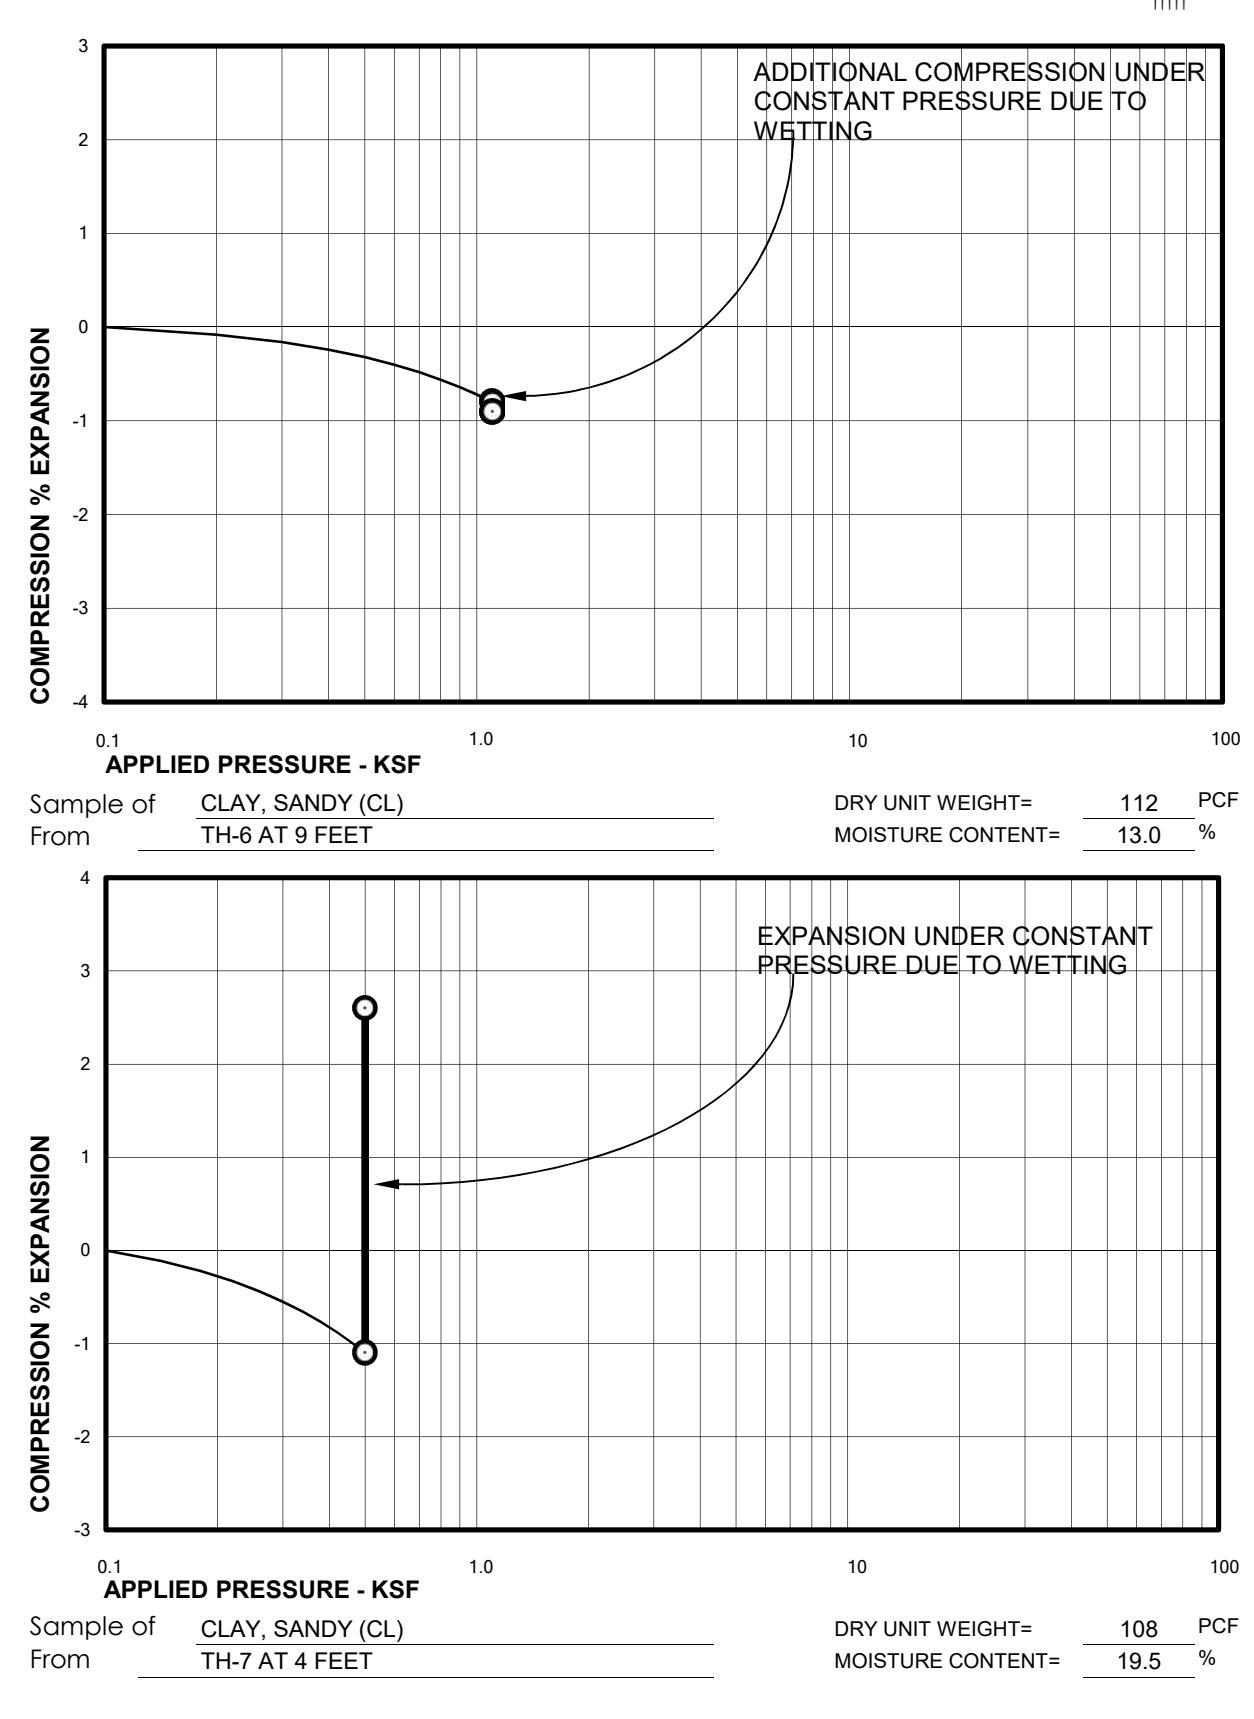
FIG. B-8

Swell Consolidation Test Results

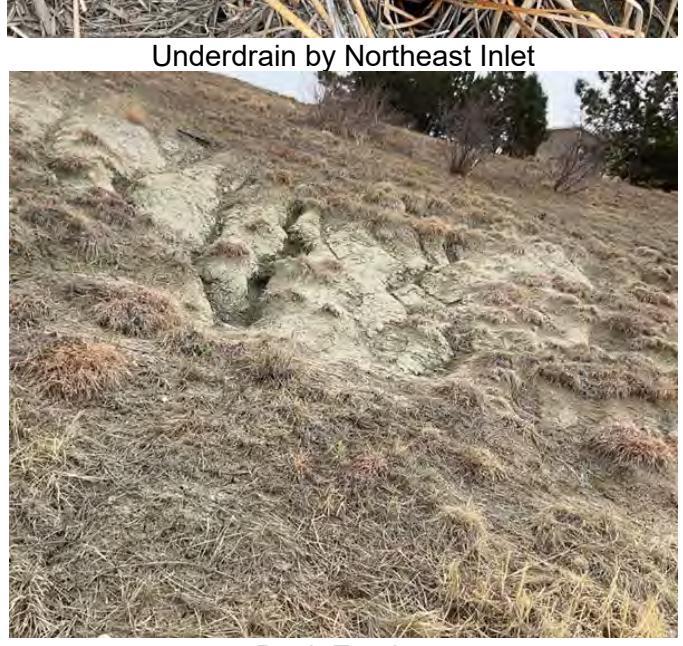
Bank Erosion
